**Flood Control Project Maintenance
Levee Inspections****LMA District Cover Sheet****Spring 2016 Levee Inspection Results****Reclamation District No. 0404 Boggs**

Spring 2016 Levee Inspection Results

Reclamation District No. 0404 Boggs

Waterway			Bank	Unit Miles
Unit No. 01 San Joaquin River			Right	2.35
	Spring (March - May)	Summer (June - August)	(September - November) Fall	Winter (December - February)
Unit Maintenance Rating (Fall Only)				
Date of Inspection	4/7/2016 - 4/7/2016			
DWR Inspector	Richard Willoughby			
Accompanied By	Bob Winter KSN

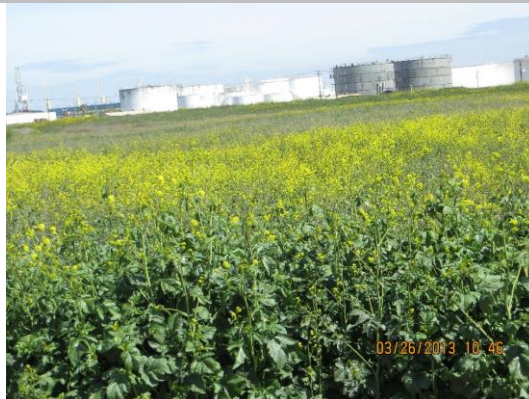
Photo 2 of 2 : UCIP_SP_2016_11087_20040.jpg

LM Start	0.65	Rating **	M	Issue No.	108 (cont)	
LM End	0.65	Issue Type +	En	Location *	WS	
Category	Supplemental			GPS Latitude/Longitude		
				Start	End	
Item	DWR UCIP Field Study			37.938670 °	37.938670 °	
				-121.335397 °	-121.335397 °	
DWR ID						
Comment Code						
Inspector Comment						
FS_ID:11087 DS_ID:17952 EP_NO: N/A Repair Type: Non-Urgent Crossing Status: Found UCIP Comments: Steel intake structure on landside of the levee. FIELD_STRUCT_DESC: 2 of 3. 30-inch pipes through levee, 22.0 feet below the crown. Waterward end with flap gates. Landward end filled with dirt. Steel intake structure on landside of the levee. Middle flap gate missing and right flap gate broken as of 1/24/07. FS Date: 3/26/2013

LS- overview of land side of the levee.

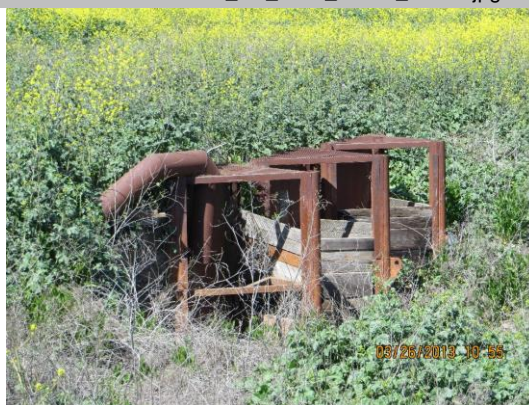
Photo 1 of 2 : UCIP_SP_2016_12383_20047.jpg

LM Start	0.66	Rating **	M	Issue No.	105
LM End	0.66	Issue Type +	En	Location *	WS
Category	Supplemental			GPS Latitude/Longitude	
				Start	End
Item	DWR UCIP Field Study			37.938670 °	37.938670 °
				-121.335397 °	-121.335397 °
DWR ID					
Comment Code					
Inspector Comment					
FS_ID:12383 DS_ID:18811 EP_NO: N/A Repair Type: Non-Urgent Crossing Status: Found UCIP Comments: Steel intake structure on LS FIELD_STRUCT_DESC: 3 of 3. 30-inch pipes through levee, 22.0 feet below the crown. Waterward end with flap gates. Steel intake structure on landside. Landward end filled with dirt. Middle flap gate missing and right flap gate broken as of 1/24/07. FS Date: 3/26/2013

LS- steel intake structure

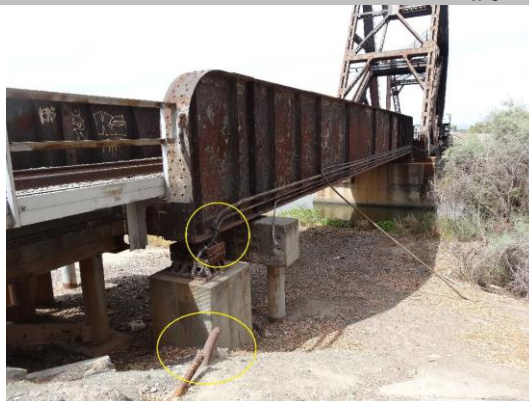
Photo 2 of 2 : UCIP_SP_2016_46810_74754.jpg

LM Start	0.79	Rating **	M	Issue No.	115 (cont)	
LM End	0.79	Issue Type +	En	Location *	LS	
Category	Supplemental			GPS Latitude/Longitude		
				Start		End
Item	DWR UCIP Field Study			37.937212 °		37.937212 °
				-121.333762 °		-121.333762 °
DWR ID						
Comment Code						
Inspector Comment						
FS_ID:46810						
DS_ID:17946						
EP_NO: N/A						
Repair Type: Non-Urgent						
Crossing Status: Found						
UCIP Comments: Appears abandoned; if so should be done so properly.						
FIELD_STRUCT_DESC: Underground telephone cable through levee and across channel. Non-operational.						
FS Date: 8/4/2015

WS view looking west: conduits thru levee and attached to bridge

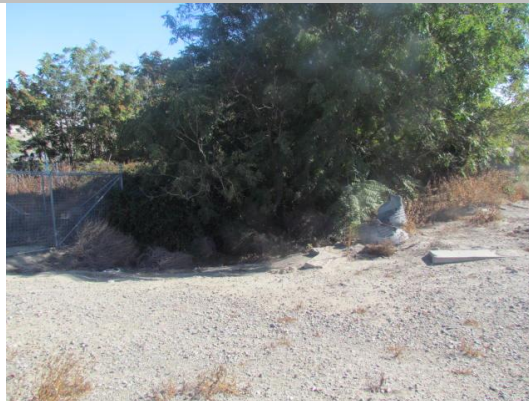
Photo 1 of 1 : SP_2016_RD0404_305_101_20160404_00022.jpg

LM Start	1.19	Rating **	M	Issue No.	101
LM End	1.19	Issue Type +	Ma	Location *	LS
Category	Earthen Levee			GPS Latitude/Longitude	
				Start	End
Item	Vegetation			37.934058 °	37.934058 °
				-121.328188 °	-121.328188 °
DWR ID	DWR_RD0404_01_s_2012_101				
Comment Code					
V2 : Remove the wild growth other than native grasses from the levee slopes.					
Inspector Comment

Looking southeast at overhanging trees on landside slope.

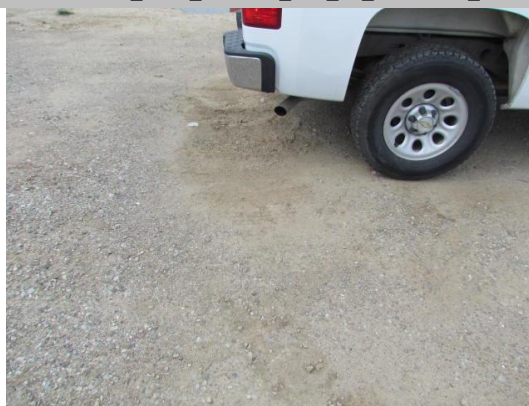
Photo 1 of 3 : SP_2016_RD0404_305_37_20160408_00059.jpg

LM Start	1.55	Rating **	M	Issue No.	37
LM End	1.55	Issue Type +	Ma	Location *	CR
Category	Earthen Levee			GPS Latitude/Longitude	
				Start	End
Item	Encroachments			37.929065 °	37.929065 °
				-121.327265 °	-121.327265 °
DWR ID	DWR_RD0404_01_s_2016_37				
Comment Code					
PI : Pipe					
Inspector Comment					
3-4 inch depression across levee crown.

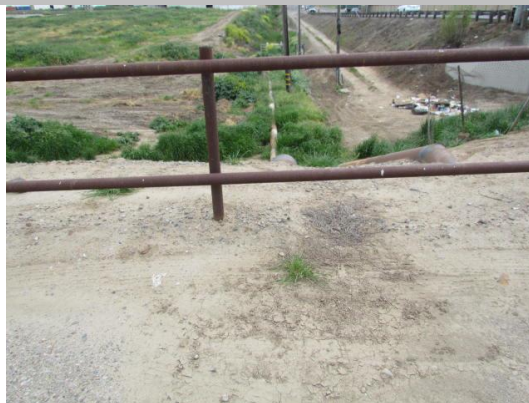
Photo 3 of 3 : SP_2016_RD0404_305_37_20160408_00060.jpg

LM Start	1.55	Rating **	M	Issue No.	37 (cont)	
LM End	1.55	Issue Type +	Ma	Location *	CR	
Category	Earthen Levee			GPS Latitude/Longitude		
				Start		End
Item	Encroachments			37.929065 °		37.929065 °
				-121.327265 °		-121.327265 °
DWR ID	DWR_RD0404_01_s_2016_37					
Comment Code						
PI : Pipe						
Inspector Comment						
3-4 inch depression across levee crown.

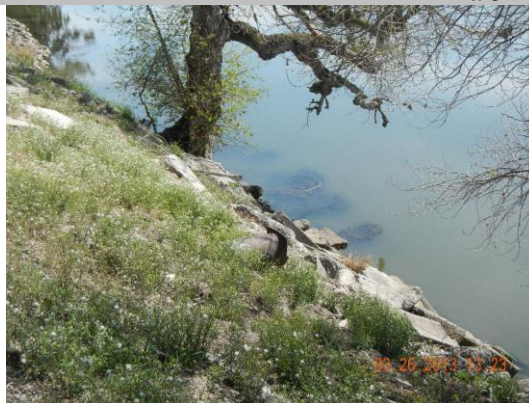
Photo 1 of 2 : UCIP_SP_2016_40487_20064.jpg

LM Start	1.64	Rating **	M	Issue No.	109
LM End	1.64	Issue Type +	En	Location *	WS
Category	Supplemental			GPS Latitude/Longitude	
				Start	End
Item	DWR UCIP Field Study			37.928090 °	37.928090 °
				-121.326215 °	-121.326215 °
DWR ID					
Comment Code					
Inspector Comment					
FS_ID:40487 DS_ID:18812 EP_NO: 10897 Repair Type: Non-Urgent Crossing Status: Found UCIP Comments: Abandoned crossing. WS pipe capped with steel pipe and LS pipe cut. FIELD_STRUCT_DESC: Abandoned 14-inch irrigation pipe. 3.0 feet below levee crown (Permit No. 10897). FS Date: 3/26/2013

WS- steel pipe capped with steel plate.

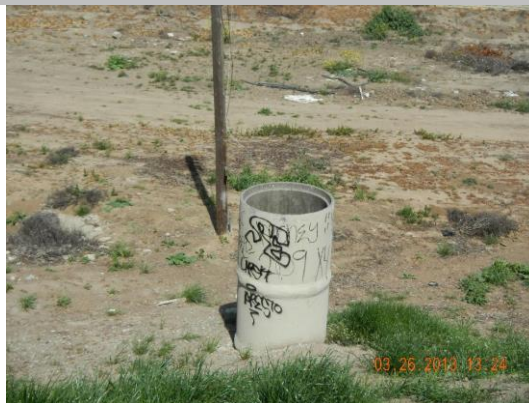
Photo 2 of 2 : UCIP_SP_2016_40487_20063.jpg

LM Start	1.64	Rating **	M	Issue No.	109 (cont)
LM End	1.64	Issue Type +	En	Location *	WS

LS- concrete standpipe on levee slope

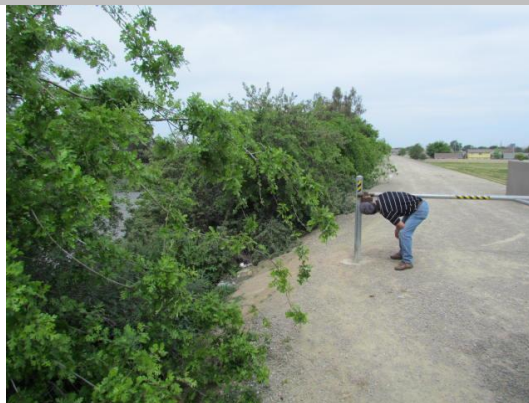
Photo 1 of 2 : SP_2016_RD0404_305_29_20160408_00066.jpg

LM Start	1.70	Rating **	U	Issue No.	29
LM End	1.77	Issue Type +	Ma	Location *	WS
Category	Earthen Levee			GPS Latitude/Longitude	
				Start	End
Item	Trim / Thin Trees			37.927517 °	37.926632 °
				-121.325515 °	-121.324868 °
DWR ID	DWR_RD0404_01_s_2015_29				
Comment Code					
T1 : Trim trees to at least five feet above ground level.					
Inspector Comment					
Dense untrimmed trees on waterward slope. Army Corp veg site.

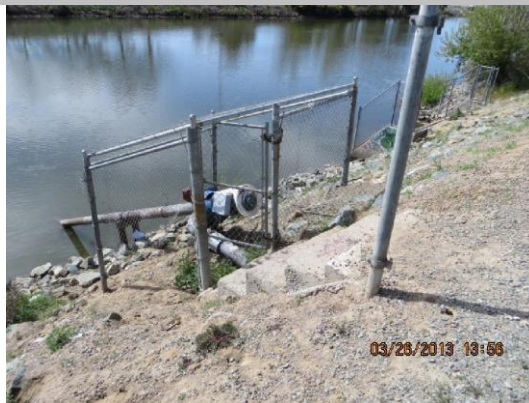
Photo 1 of 2 : UCIP_SP_2016_40797_20073.jpg

LM Start	1.81	Rating **	M	Issue No.	110
LM End	1.81	Issue Type +	En	Location *	LS
Category	Supplemental			GPS Latitude/Longitude	
				Start	End
Item	DWR UCIP Field Study			37.926168 °	37.926168 °
				-121.324514 °	-121.324514 °
DWR ID					
Comment Code					
Inspector Comment					
FS_ID:40797					
DS_ID:17961					
EP_NO: 6560					
Repair Type: Non-Urgent					
Crossing Status: Found					
UCIP Comments: Damaged siphon breaker in pipe riser near the landward shoulder.					
FIELD_STRUCT_DESC: 8-inch pipe through the levee, 7.0 feet below the crown, chain link fence around pump and motor on the waterward slope. (Permit. No. 6560)					
FS Date: 3/26/2013

WS- slanted pump, pipe, and concrete steps on levee slope.

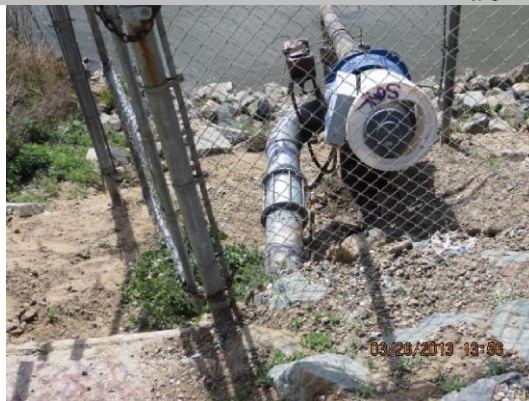
Photo 2 of 2 : UCIP_SP_2016_40797_20072.jpg

LM Start	1.81	Rating **	M	Issue No.	110 (cont)	
LM End	1.81	Issue Type +	En	Location *	LS	
Category	Supplemental			GPS Latitude/Longitude		
				Start	End	
Item	DWR UCIP Field Study			37.926168 °	37.926168 °	
				-121.324514 °	-121.324514 °	
DWR ID						
Comment Code						
Inspector Comment						
FS_ID:40797						
DS_ID:17961						
EP_NO: 6560						
Repair Type: Non-Urgent						
Crossing Status: Found						
UCIP Comments: Damaged siphon breaker in pipe riser near the landward shoulder.						
FIELD_STRUCT_DESC: 8-inch pipe through the levee, 7.0 feet below the crown, chain link fence around pump and motor on the waterward slope. (Permit. No. 6560)						
FS Date: 3/26/2013

WS- slanted pump, and pipe on levee slope.

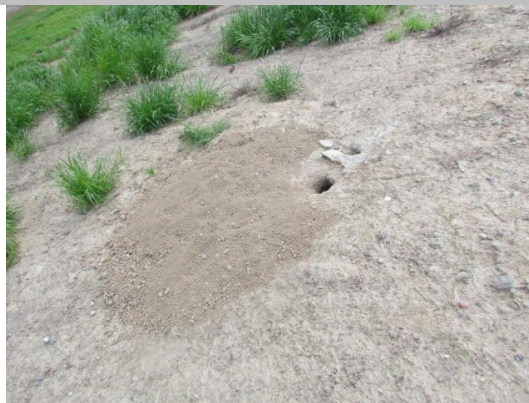
Photo 2 of 2 : SP_2016_RD0404_306_21_20160408_00025.jpg

LM Start	0.68	Rating **	U	Issue No.	21 (cont)	
LM End	0.94	Issue Type +	Ma	Location *	LS	
Category	Earthen Levee			GPS Latitude/Longitude		
				Start		End
Item	Animal Control			37.919245 °		37.916652 °
				-121.307705 °		-121.305085 °
DWR ID	DWR_RD0404_02_s_2016_21					
Comment Code						
A1 : Exterminate rodents and backfill and compact or grout burrows.						
Inspector Comment						
Large holes noted on landward slope.

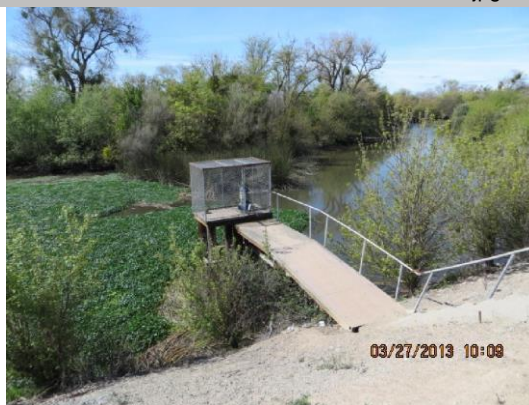
Photo 1 of 2 : UCIP_SP_2016_10908_18182.jpg

LM Start	0.73	Rating **	M	Issue No.	70
LM End	0.73	Issue Type +	En	Location *	LS
Category	Supplemental			GPS Latitude/Longitude	
				Start	End
Item	DWR UCIP Field Study			37.919336 °	37.919336 °
				-121.306782 °	-121.306782 °
DWR ID					
Comment Code					
Inspector Comment					
FS_ID:10908					
DS_ID:18781					
EP_NO: 3340A					
Repair Type: Non-Urgent					
Crossing Status: Found					
UCIP Comments: - Not working for 5 years- Golf club staff- Wooden					
Walkway; Concrete steps- Damaged siphon breaker					
FIELD_STRUCT_DESC: 6-inch pipe through the levee, 2.0 feet below					
the crown. Pump on pile structure in stream. Shut-off valve and siphon					
breaker on the waterward shoulder. Timber walkway on the waterward					
slope. One CM cutoff wall. (Permit No. 3340A)					
FS Date: 3/27/2013

WS- pump on steel structure and wooden walkway

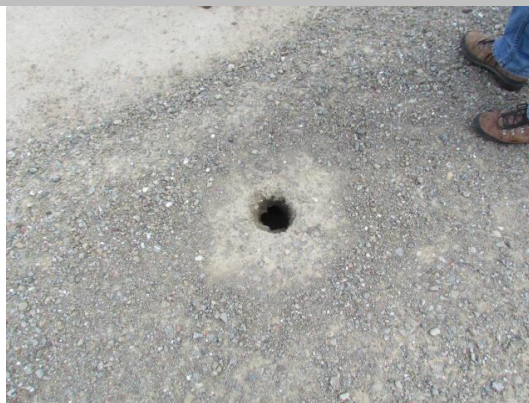
Photo 2 of 2 : SP_2016_RD0404_306_20_20160408_00027.jpg

LM Start	1.08	Rating **	U	Issue No.	20 (cont)
LM End	1.08	Issue Type +	Ma	Location *	LS

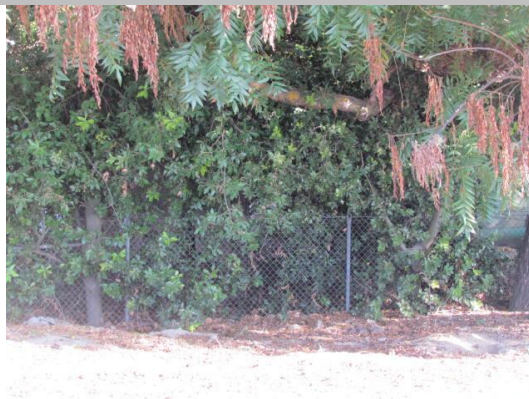
Photo 1 of 4 : SP_2016_RD0404_306_67_20160404_00005.jpg

LM Start	1.13	Rating **	M	Issue No.	67 (cont)
LM End	1.13	Issue Type +	Ma	Location *	LS

Looking northeast at dense vegetation inside fenced area near pump station on landside toe.

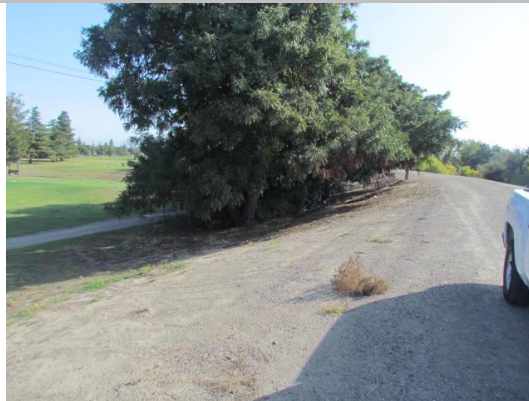
Photo 4 of 4 : SP_2016_RD0404_306_67_20160404_00008.jpg

LM Start	1.13	Rating **	M	Issue No.	67 (cont)	
LM End	1.13	Issue Type +	Ma	Location *	LS	
Category	Earthen Levee			GPS Latitude/Longitude		
				Start		End
Item	Trim / Thin Trees			37.916337 °		37.916337 °
				-121.301888 °		-121.301888 °
DWR ID	DWR_RD0404_02_s_2012_67					
Comment Code						
T3 : Trim and thin trees to allow visibility of the ground and room to flood fight.						
Inspector Comment						
Dense vegetation around propane tank inside fenced area.

Looking east at dense vegetation near pump station on landside toe.

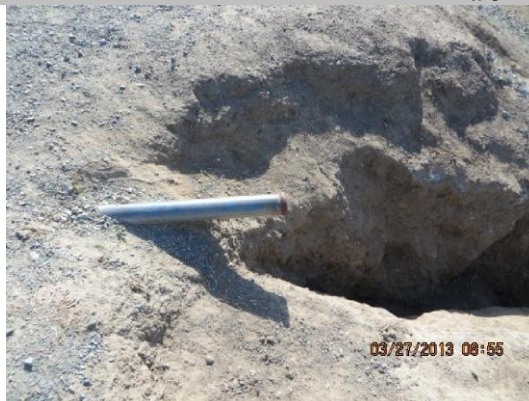
Photo 1 of 2 : UCIP_SP_2016_10853_18134.jpg

LM Start	1.55	Rating **	U	Issue No.	69
LM End	1.55	Issue Type +	En	Location *	LS
Category	Supplemental			GPS Latitude/Longitude	
				Start	End
Item	DWR UCIP Field Study			37.918411 °	37.918411 °
				-121.295128 °	-121.295128 °
DWR ID					
Comment Code					
Inspector Comment					
FS_ID:10853 DS_ID:18792 EP_NO: 3340 Repair Type: Urgent Crossing Status: Found UCIP Comments: Abandoned and capped 3-in GI pipe found on WS. Damaged air-valve/siphon breaker found on LS.Gully formed due to leaky pipe. A pump house found on LS but it needs to be verified by LMA whether this is associated with this crossing. FIELD_STRUCT_DESC: Abandoned and capped 3-inch GI pipe through levee, 1 feet below the crown; pile structure in stream. damaged siphon breaker at the toe of the landward slope. (Permit No. 3340) FS Date: 3/27/2013

WS- capped 3-inch GI pipe

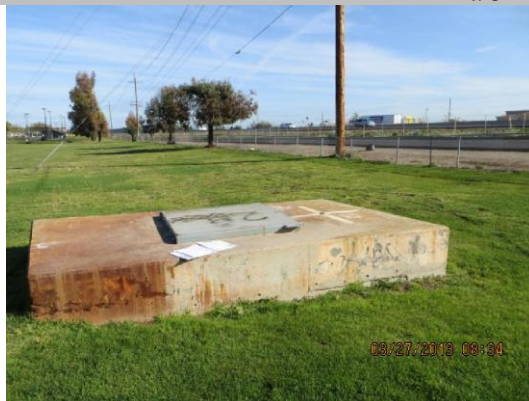
Photo 1 of 2 : UCIP_SP_2016_10846_18127.jpg

FS_ID:10846
DS_ID:18804
EP_NO: N/A
Repair Type: Non-Urgent
Crossing Status: Indicator Found
UCIP Comments: Only a 7 ft x 14 ft concrete vault found on LS. Needs a sign post. Bob Winter from KSN (representative of RD 404) will investigate on this crossing.
FIELD_STRUCT_DESC: 1 of 2. 42-inch-diameter pipelines under the levee. Pipes cross under the channel.
FS Date: 3/27/2013

LM Start	1.76	Rating **	M	Issue No.	68 (cont)
LM End	1.76	Issue Type +	En	Location *	WS

LS- 7' x 14' concrete vault.

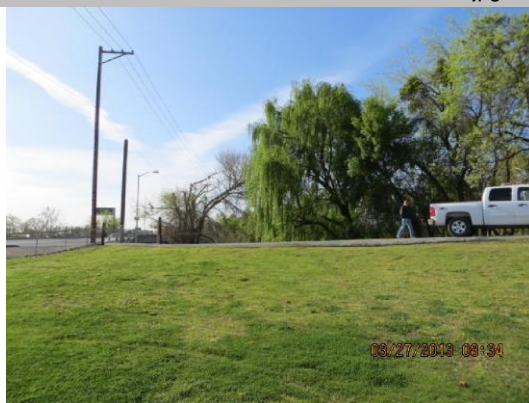
Photo 2 of 2 : UCIP_SP_2016_10846_18126.jpg

Crown view of the levee.
